A CASE HISTORY

| Project: Balfour Residence Gallup, NM | Structural Engineer: Structural Design Associates Albuquerque, NM | Underpinning Contractor: Vic Peery Construction, Inc. Albuquerque, NM |

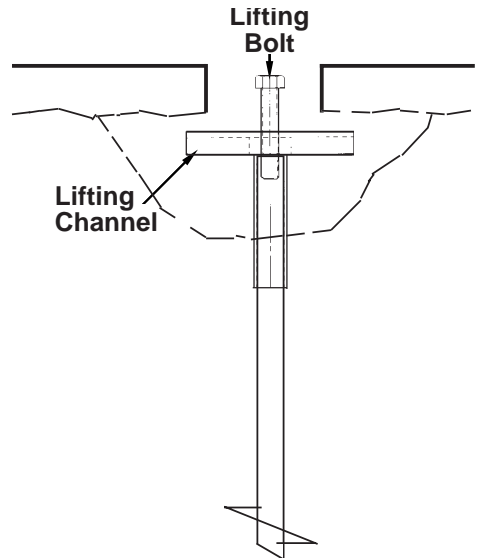
Cross-sectional view of slab lifting bracket

Repair: Eighty-seven Chance HELICAL PIER[®] Foundation Systems screw anchors were installed through cored 6"-dia. holes in the slab on a 6' grid to allow the slab to be raised with a slab bracket on the top of the anchor. Average installation depth of the anchors was 10'. As the dead weight of the slab and the service live load totalled 40 PSF, the anchors were only required to support 1,500 lb. The 6"-dia. helices on the solid-steel 1½" square shaft were installed to a minimum torque of ____ ft.-lb. for a minimum load of 3000 lbs. per anchor using a portable 2,500 ft.-lb. hydraulic driver. Voids created by lifting the slab were grout filled.

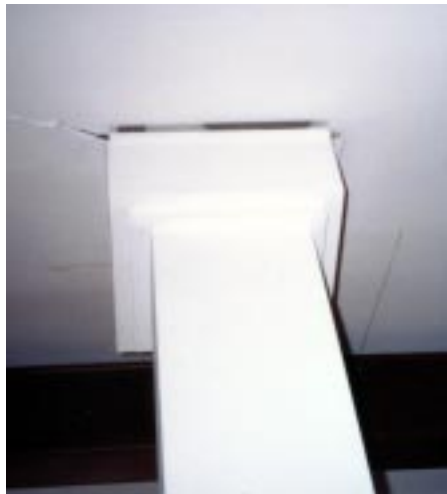
Job Description: Due to a non-uniform, lightly compacted, sand fill below the interior slab of this single story, wood frame with brick veneer home, the floor slab was experiencing differential settlement, primarily along a central interior corridor. The perimeter of the house was bearing on a competent clay and was stable. Geological investigation revealed that competent hard sandy clay at a depth of 8' was satisfactory to bear an underpinning anchor system.

1"+ gap can be seen between column and ceiling.

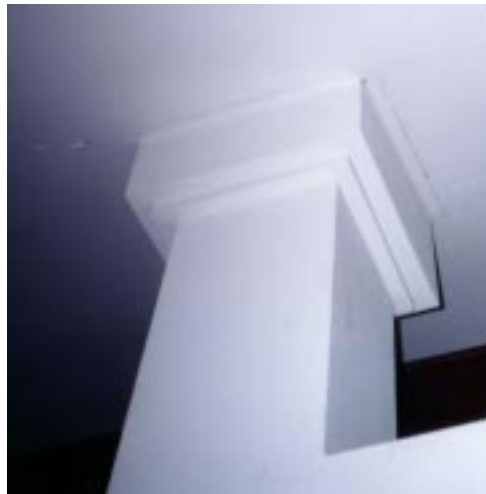
Gap is closed after lifting slab.
