CASE STUDY

Project: Industrial Pile Repairs Beta Avenue Burnaby, B. C.	Geotechnical Engineer: Geopacific Consultants Burnaby, B. C.	Structural Engineer: Somerset Engineering Burnaby, B. C.	Contractor: Dragonwood Enterprises Burnaby, B.C.
---	---	---	--

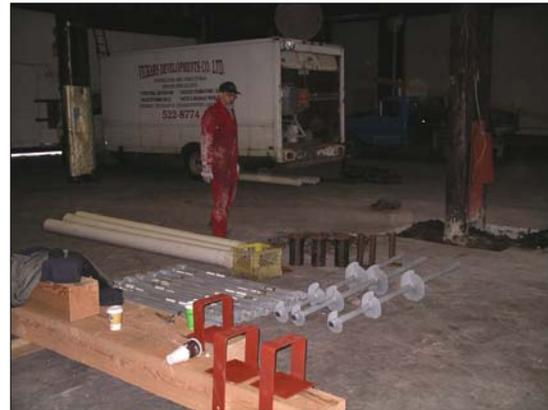
During the tenancy changes at this 80 plus years (industrial building), the pilings supporting the roof were found to be rotten and damaged by impact approximately 4'-5' above the concrete floor slab on the interior of the building. Investigation of this revealed that the heart of the creosoted pilings which extended in pairs terminating 6' and 14' above the slab, were rotten in the core and needed to be replaced. The pilings extend down approximately 27' through the top of the slab to undisturbed adequate bearing ground or glacial till. They were found to be continuous and brought through the floor to support post loads in turn supporting roofing truss structures for the high industrial ceiling, over.

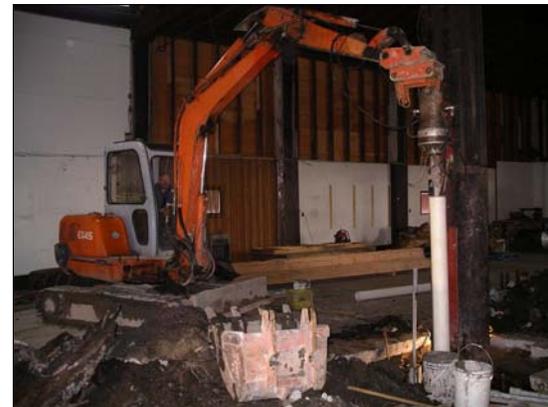
Geotechnical investigations by means of a drilling rig revealed the soil profile within 10' of the subject (degraded) piles was approximately 4-5' of mixed contaminated fill over about 22' of silts and sandy silts with a sudden transition into dense glacial till with SPT blows in excess of 80 blows per foot within 2' of the top surface of the till.

Helical PULLDOWN™ Micropiles were selected due to the smaller and lightweight equipment that we use for their installation which can be better controlled around degraded pilings so inadvertent danger from any contact would be minimized. The helical PULLDOWN™ Micropiles selected were 1 1/2" SS5 square shaft using a 6-8-10 triple helix lead. The piles were placed through the bottom of a shallow surface excavation around the piles, 27' – 30' deep, including 2'-3' penetration into the dense underlying glacial tills.

Access to the area surrounded the degraded piles was made by cutting a hole through the existing floor slab and excavating down approximately 3'-4' to get rid of deleterious and contaminated fills including metal slag heaps, which initially precluded placement of the pilings. Once that was completed, the PULLDOWN™ pile was placed through a 6" PVC sleeve to minimize any negative skin friction or downdrag forces following the repair. The sleeve was brought up to within 6" of the underlying slab
