A CASE HISTORY

Project:
Elerding Residence
Sitka, AK

Structural Engineer:
Straiger Engineering
Sitka, AK

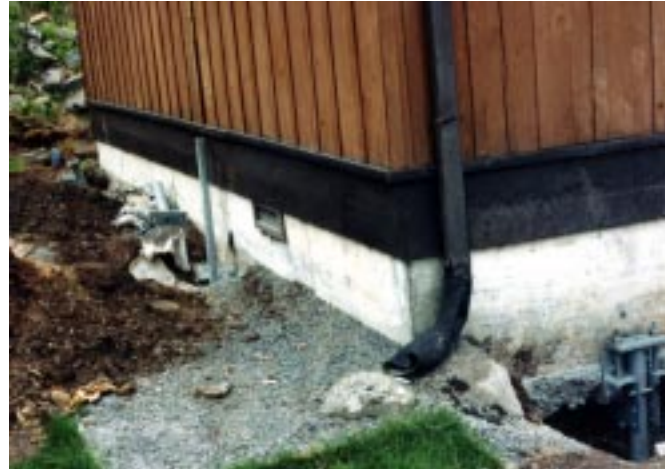
Twelve screw anchors were installed on the outside.

Repair: Seventeen SS5 screw anchors with 8" and 10" helices were installed from 12' to 36' depths to reach load bearing soils. Five of the piers were installed inside the house through 12"-square holes cut through the wooden floor. Chance underpinning brackets were installed under the foundation and onto the anchors. Using hydraulic jacks inserted into the brackets, the foundation was leveled.

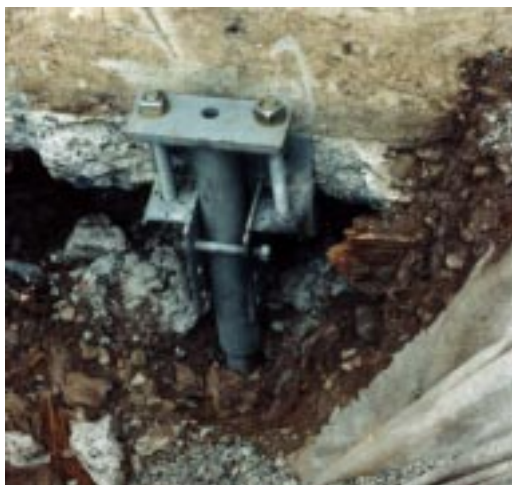
HELICAL PIER underpinning bracket

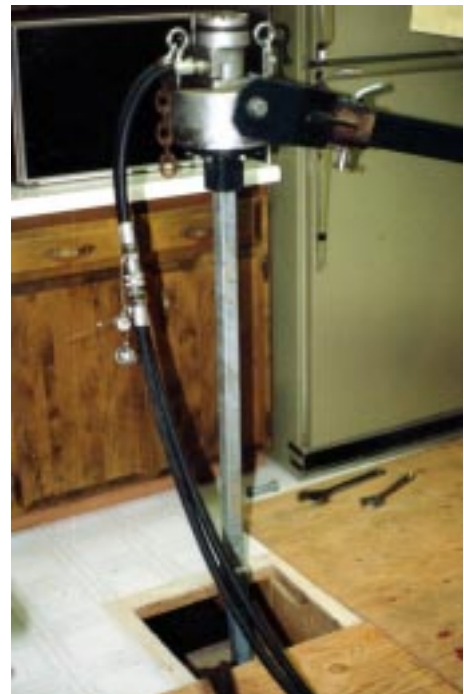
Portable hydraulic driver
installing screw anchor
through kitchen floor
→
