## CASE STUDY

<b>Project:</b> Fortin Residence. White Rock, B.C.	<b>Structural Engineer:</b> Somerset Engineering. Burnaby, B.C.	<b>Geotechnical Engineer:</b> Geopacific Consultants. Burnaby, B.C.	<b>Contractor:</b> Vickars Construction. Burnaby, B.C.
--	--	---	--

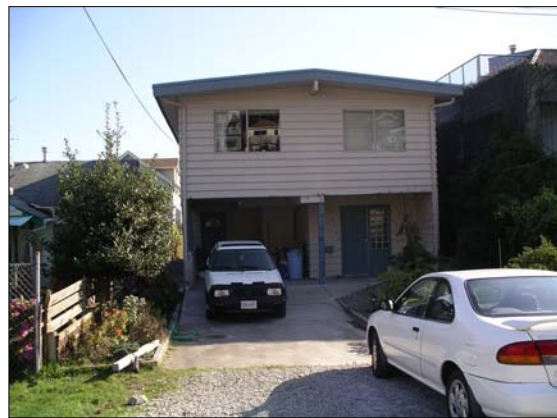
A 35 year old home on an in filled lot site near the ocean by marine drive in this initially small summer community. The house had undergone a period of rapid differential settlement due to rotting and resultant failure of foundation support, of untreated wooden pilings. At the time of repair the rear portions of the buildings had settled more than 12 inches ( 300 mm). The home, despite the large amount of differential settlement, was in very good condition as it was protected from damaging bending and twisting of its wood frame by a very stiff foundation assembly over the failing piling.

It was elected to repair the home by replacing the degraded wood pilings with portably placed high capacity pilings due to access difficulties associated with the proximate surrounding homes. Since the foundations were reinforced adequately to allow a pile supported structure it was relatively easy using the patented PULLDOWN™ Piling to modify all the attachments to allow re-leveling.

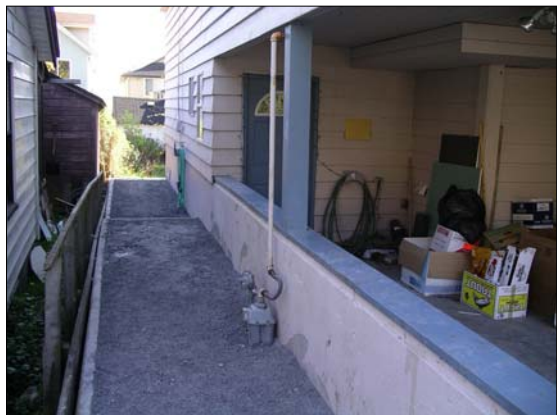
Geotechnical investigation including boreholes on this and the sister property to the east revealed 2-3 feet of sandy fills followed by 20 feet of logs, stumps sand , construction debris with broken siding and sawdust mixed with sands and silts. By 26-30 feet natural deposits of sand appear transitioning into dense sands and gravels by 32-34 feet overall depth .
