# NCE UNDERPINNING ANCHORING REPORT

## **A CASE HISTORY**

**Project:** Kellogg **Residential Summer House** Bay Head, New Jersey

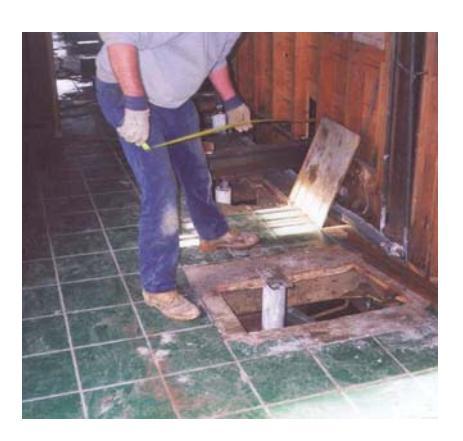
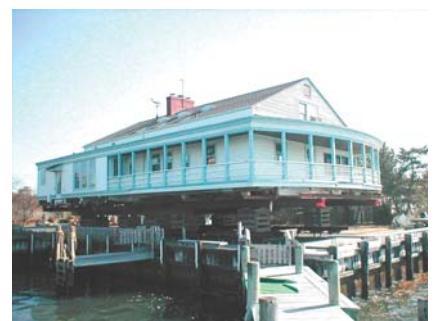
the outside bearing wall with cross beams and lateral bracing. Helical piers also were installed around the fireplace for a total of some 72 piers installed. Small access holes (approx. 2 x 3 feet) were cut through the ground floor at predetermined locations for the piers to be screwed into place to a uniform depth. The jacking frames extended only 2 to 3 feet above grade and were designed to become part of the final foundation system. Once in place, a steel cap beam was attached and jacks positioned. With the upper floors supported by this temporary system, the first floor

walls were removed and a timber cribwall installed. All piling, steel beams, and bracing were installed and cut off as required by Hydro-Marine Construction Co., Inc. (HYDRO) a Chance certified installer.
