CHANCE™ HELICAL PULLDOWN® MICROPILES REPORT

A CASE HISTORY

Project: Multi-Generational Building, Burlington, VT

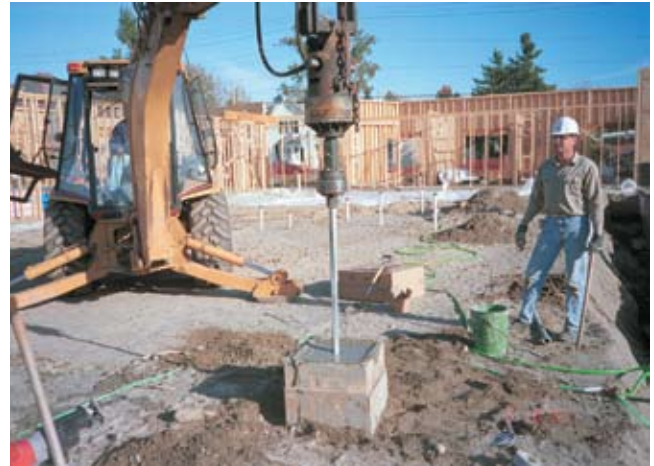
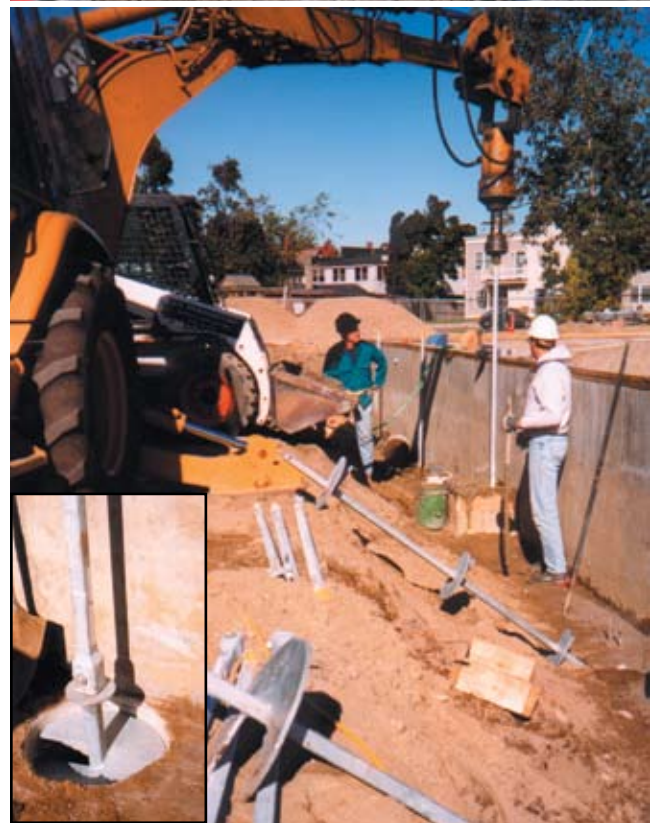
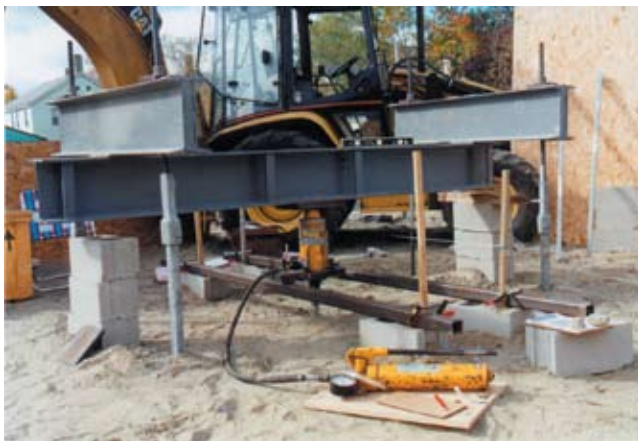
The soil on grade under part of the building was a layer of fill as deep as 27 feet, mainly of cinders and ash. The original design specified a footing 4 feet wide with a reinforced-concrete wall 5 feet high. Before framing began, some of the foundation walls had settled more than 5 inches.

Chance HELICAL PULLDOWN® Micropiles were installed and a load test was performed. Each pile was rated for a 35 kip working load and a 70 kip ultimate capacity. Of the total 75 HELICAL PULLDOWN® Micropiles installed on the job, 35 were installed through holes cored in the footing and then attached to the foundation walls by epoxy-embedded rebar and concrete haunches. In addition, 40 Chance Helical Piers with new-construction brackets were used to support the column loads and structural slab.
