HELICAL PULLDOWN® Micropiles Report

A CASE HISTORY

Project: Condominium Building Richmond Hill, Ontario	Geotechnical Consultant: Soil Mat Engineers and Consultants Hamilton, ON	Consultant: The SPG Engineering Group Ltd. Oakville, ON	Contractor: EBS Engineering Construction Breslau, ON
-------------------------------------------------------------------	---------------------------------------------------------------------------------------	----------------------------------------------------------------------	-------------------------------------------------------------------

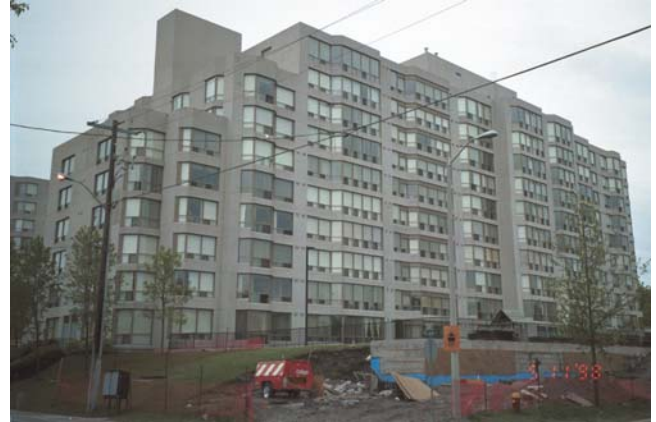
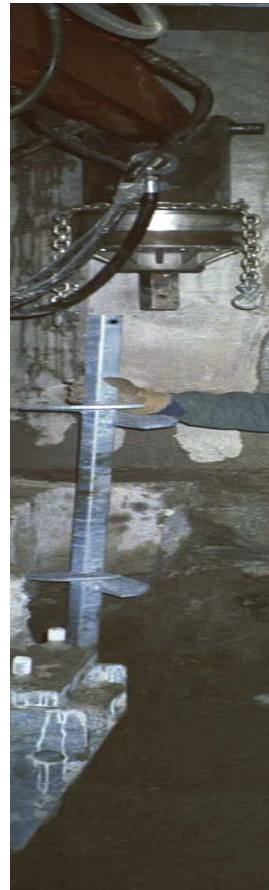
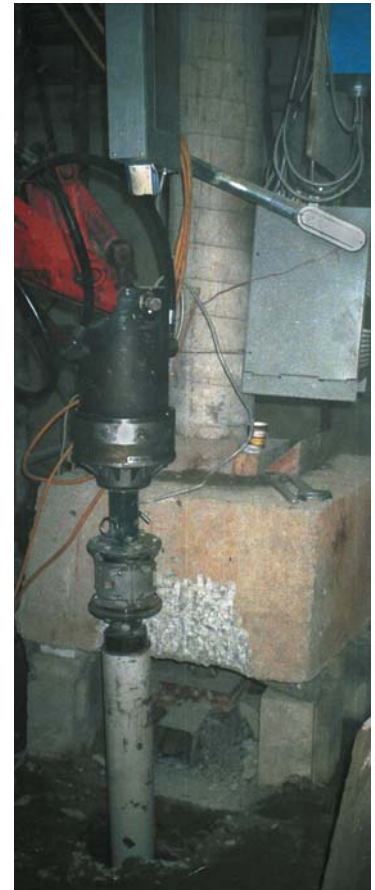
The Helical Pulldown® Micropile size and configuration used was the SS200 with 8", 10" and 12" diameter helices. A 6" diameter grout column around the shaft was sleeved with PVC pipe above the helices to increase lateral stability and prevent negative skin friction on the piles if the clay till were to continue to settle. Installation depths varied from 34 to 44 feet on the 83 piles installed to a 60-kips minimum allowable working load or a 120-kips minimum ultimate load capacity.
